TECH BYTES

National Fertilizers Limited, Technical Periodical
(Q-1,2023-24)
(For Internal Circulation)

AVOIDING STOPPAGE OF HRU-3 BY ATTENDING THE FLUE GAS LEAKAGE NEAR BURNER NUMBER #5 & #6 ONLINE IN RUNNING CONDITION OF HRU-3 OF CAPTIVE POWER PLANT

LICA-37 (Carbamate Solution Level Measurement) MODIFICATION JOB

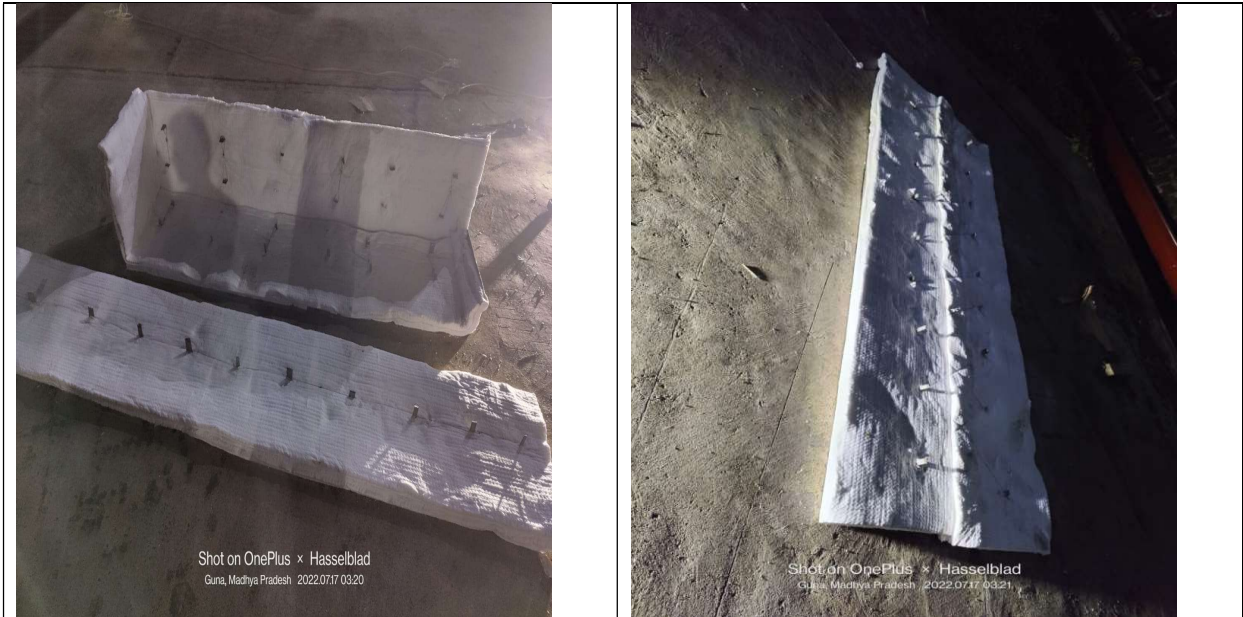
On 18th July-2022 HRU-3 was running in cogeneration mode with GTG-3 to meet steam requirement of the plant. During field round massive flue gas leakage was observed near burner no. 5 & 6 of HRU-3.

The flue gas leakage was so massive that it required to shutdown HRU-3 to attend the leakage. The flue gas leakage could have been due to fall of refractory material in side furnace, so repair work could have only be done by going inside furnace area. Man, entry inside furnace to attend/repair the refractory inside the furnace can be allowed only after natural cooling of furnace/boiler, which generally takes 36-48 hrs usually. Time required to repair refractory inside furnace is 3-4 days for short term repair. So, a minimum of 5-6 days shutdown was required to attend flue gas leakage.

Inconel plate & Box with Cerawool insulation

To attend the leakage one number plate and one number box of Inconel 601 and SA-387 P11 material was fabricated. Both Inconel and P11 material plates were welded together and P-11 plate was used as a lining plate over Inconel plate. High temperature Cerawool insulation layering was done over fabricated plate and box to protect it from direct exposure of heat.

However, to fabricate the plates, dimensions were required to be taken of the damaged portion. But due to high temperature, it was not possible to go near the leakage area to check the dimensions. The approx. dimensions were taken by going to the nearest possible location through crane and jhoola. Some long ½ inch pipes were used to check the dimensions approximately by standing on the jhoola. Even thermal scanning of the area was carried out and from the image, dimensions were interpolated. After having a view of the approximate dimensions of the damaged portion, one number plate and one number box of Inconel 601 and SA-387 P11 material was fabricated with Cerawool insulation.

During fabrication, the plate and box was repeatedly taken near the damaged portion by crane for rectification so that the plate and box were made of perfect dimensions.

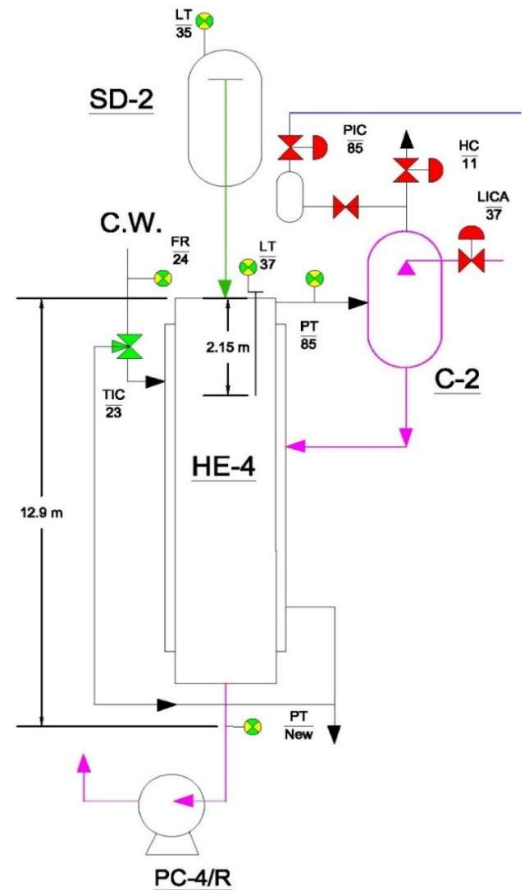
In HE-4 Exchanger, Level measurement of carbamate solution is done by capacitance probe of 2150 mm length which is installed on the top of the Exchanger. But for some unknown reasons, the probe stopped giving any indications. After inspection, it was found that the probe had got internally short circuit, making it impossible to repair or replace it while the plant was running.

Therefore, a new transmitter was installed at the bottom of the HE-4 exchanger as shown in picture. For second stage system pressure reading (vapour pressure) there is already a pressure transmitter PT-85 on top of HE-4 exchanger.

So the reading of both pressure transmitter are computed in another YS-1700 controller as below

Total height is	= 12.9 mtrs
Density inside is	= 980 kg/m ³
Maximum Head pressure	= 12.9 x 980
	= 1.2642 Kg/cm ²
	= 12642 mm of WC

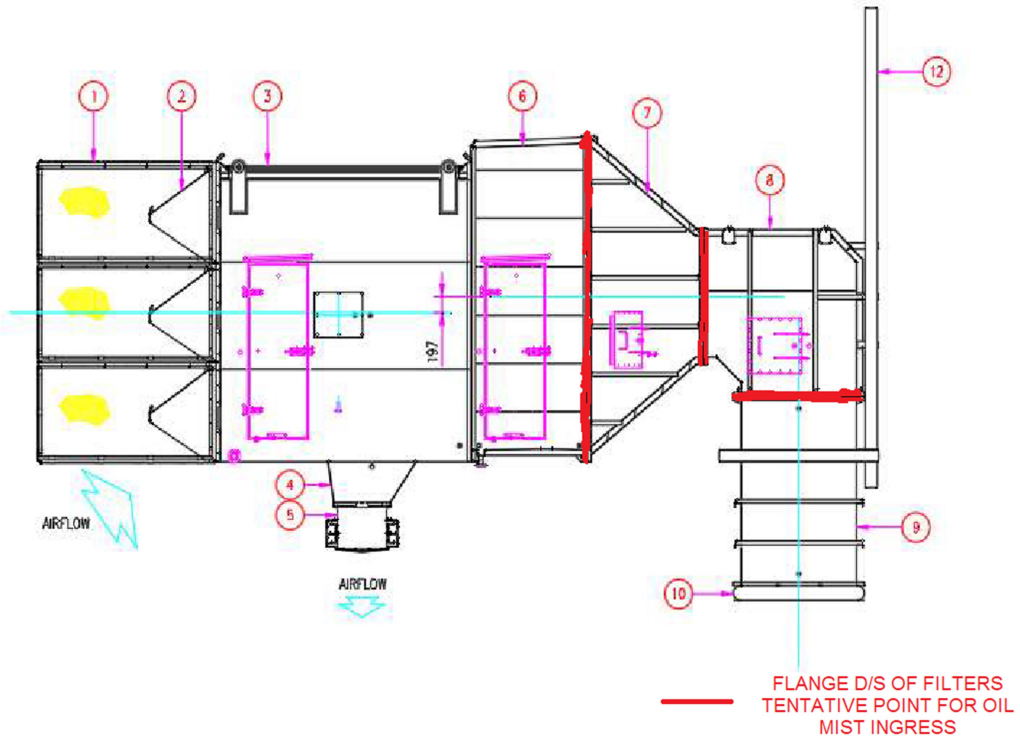
GENERAL ARRANGEMENT OF AIR INTAKE SYSTEM

The oil mist exhaust line is in immediate vicinity of the air intake housing. There is high possibility of ingress of oil mist fumes through intake filters and also at downstream of filters via flange joints, in case the sealing is damaged. During air intake chamber inspection in Mar-'22 some traces of oil were found at downstream of static filters. At that time, all flange joints of Air Intake system were sealed with M-seal putty as a precaution.

Ingress of this oily substance in presence of dust particles forms a sticky compound which have tendency to stick to the Gas Generator rotor & stator blades. Deposition of material would result into fouling and ultimately the surging of compressor.

Since the oil mist exhaust line is in the immediate vicinity of air intake housing, it might be the source of oily substance found inside the housing. So it became necessary to re-route the oil mist exhaust far from the air intake housing.

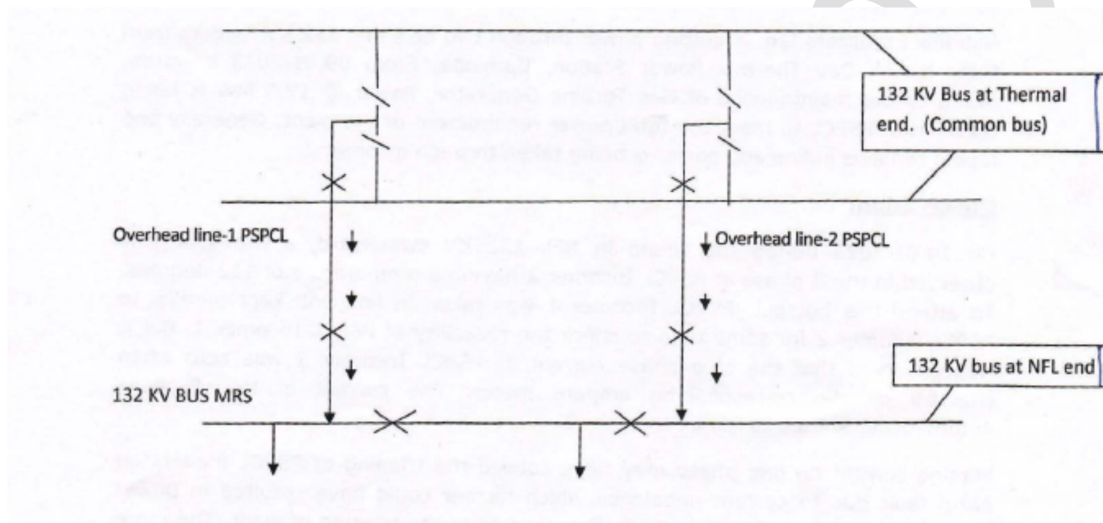
On 14.01.2023 during the round in NFL 132 KV switchyard, a hot spot was observed in the B phase at PSPCL Incomer 2 having a temperature of 112 degrees. To attend this hotspot, PSPCL Incomer 1 was taken in line and kept parallel to PSPCL incomer 2 for some time to check the reliability of PSPCL Incomer 1. But it was observed that the blue phase current at PSPCL Incomer 1 was zero when checked on the corresponding ampere meter. The current of this B-phase automatically shifted to PSPCL Incomer 2.

1. The healthiness of the 132 KV line of PSPCL Incomer 1 was checked by PSPCL staff and found ok.
2. Testing and maintenance of circuit breakers, CTs, and isolators of PSPCL Incomer 1 were carried out and found ok.
3. On further study following phenomena may occur due to following reasons:
When both PSPCL feeders are taken in line in parallel, 132 KV bus at the Thermal end and NFL end become in parallel, and as per current law:
 - a. Current splits between the branches:-
The current along the branch with the smallest resistance will be larger than the branch with higher resistance. The total current in the circuit must remain constant.

As the length of feeders from PSPCL thermal end is approximately 2.5 KM and each line has nos. of isolators, towers etc. Hence it seems that both lines may have different impedance. In view of this, above said phenomena at point no. 3 may occur. If we run both feeders independently (i.e. one feeder at a time), this problem does not occur. The circuit diagram is as given below:

If we run both PSPCL feeders in parallel to increase the system reliability, the situation of current imbalance occurs this further may cause tripping of the plant on current imbalance. To avoid such a situation both feeders should not be run in parallel. In the emergency, if changeover of the feeder is required paralleling can be done only for short duration .
