TECH BYTES

National Fertilizers Limited, Technical Periodical,
(Q-3, 2022-23)
(For internal circulation)

Tripping of Main Breaker of GTG-3 on Stator Neutral Earth Fault Protection at N.F.L. Vijaipur – A Case Study

Fault Diagnosis & Remedial Action in Tripping Problem of Reciprocating HP Carbamate Pump PA-2C/N in Urea Plant

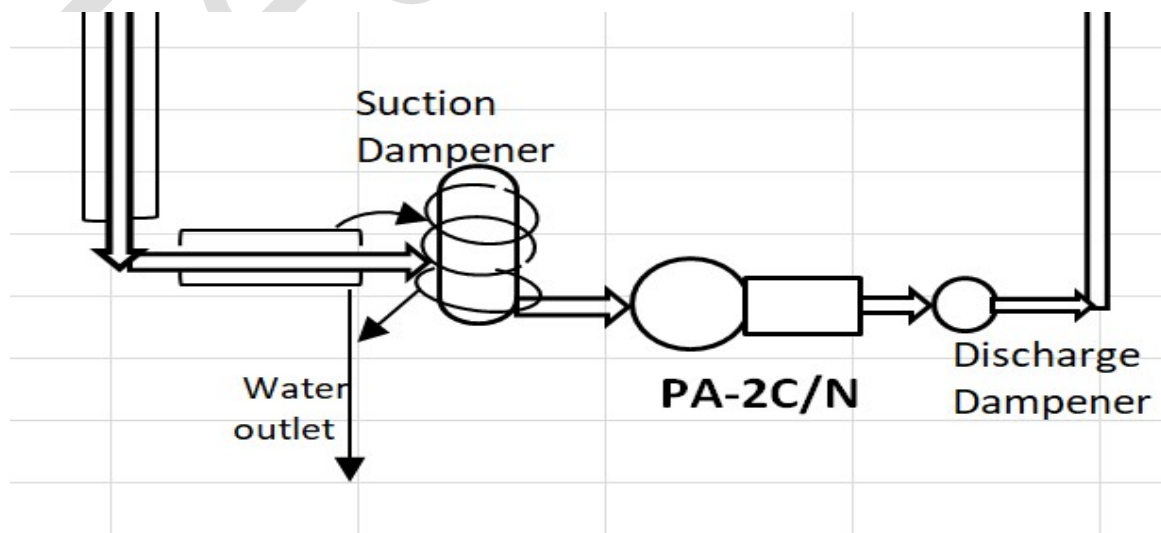
- ❖ A Technical analysis of the Operating Process parameters was carried out. The operating suction pressure of the pump was observed to be 67-68 Kg/Cm² and temperature of carbamate was 118-120°C. The detailed study of operating manual revealed that the vapour pressure of carbamate at 120 °C is about 65 Kg/Cm². So it was observed that the operating suction pressure is very near to vapour pressure of carbamate at its present operating temperature. During suction stroke of the pump there is possibility that there is a localized vapour formation within the cylinder of the pump causing unloading of the pump, vapors being compressible fluid.

As the pressure of 1st Stage (67.7Kg/cm²) i.e. suction pressure of pump could not be increased so it was decided that the temperature of the fluid to be lowered to avoid vapor formation in process. As suction line of the pump was having a jacketed construction, So Raw water injection was provided in these jacketing lines to reduce the inward temperature of suction line of the order 110°C-112°C which eliminated the vapor locking in the pump owing to smooth operation of the equipment.

The schematic representation of the modifications done is as under:-

The above whole exercise was done in-house and with joint efforts of Mechanical, Electrical & Production the problem of tripping of PA-2C/N was resolved by providing Cooling Water in suction line jacket of the pump. This resulted in increased reliability of the Pump as the machine is in continuous operation since this modification without any tripping and maintenance job of valve bodies/O-rings has also reduced to appreciable extent.

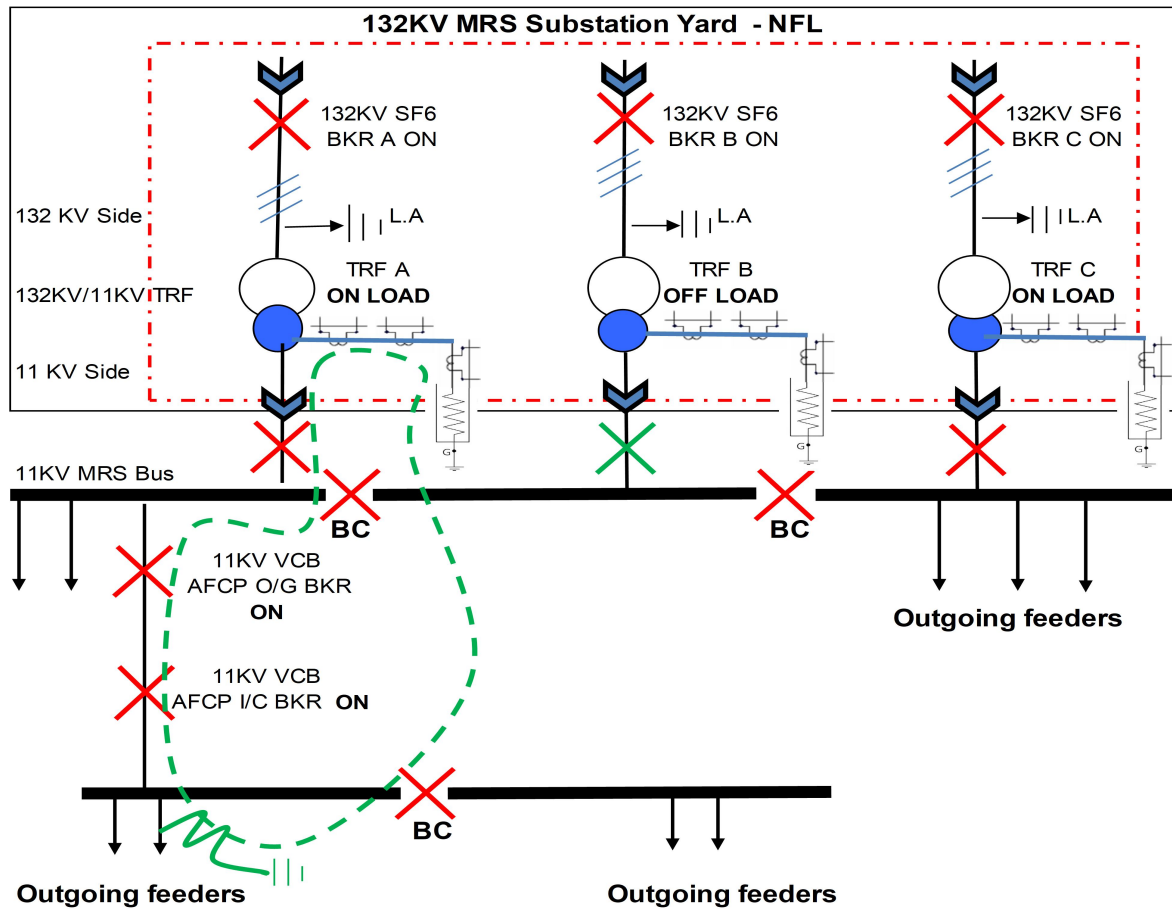
Figure -1

On 08th May'22, at around 03.00 am, a L-G fault occurred (Fault current (If) of 184Amps) in the 11kV capacitor banks installed at AFCP. During this event, 11kV Side of TRF-A in MRS tripped on actuation of Restricted Earth Fault (REF) relay (current setting 160Amps) and 132kV Side TRF A tripped on inter-tripping. Since no power was available, this led to tripping of all downstream plant loads of section A. However the load of section B (i.e on TRF-C) was uninterrupted. No relay was found operated at AFCP Feeders, however all the 11kV fuses before capacitor banks were found blown. The effected 11kV bus section at MRS was checked & found healthy. This was again charged by through TRF-B and plant load was normalized with TRF-B and C.

(* Refer figure-1 below)

The effected Transformer-A was isolated & thorough inspection/testing of transformer was performed (that included insulation resistance Test(IR), Magnetic Core Balance Test, Break Down Voltage Test of transformer Oil (BDV)) were performed & results were found within the acceptable limits. The REF Relay testing was carried out & relay was found healthy. With above result it was suspected that Unit protection of Transformer (64R) might have given spurious tripping during out-zone fault at 11kV Capacitor Bank of AFCP.

During protection scheme testing, the REF relay was found operating during downstream fault of AFCP. It was observed that the CT of 2000/1 Class- 5P10 installed in Neutral Ground resistor (NGR) of TRF-A was used in the REF protection scheme in-place of the 1600/1 Class – PS Neutral CT available in neutral busing of TRF A. Due to the mismatch in ratios & accuracy class existing between the phases and neutral CT's, the REF relay mal-operated for the Out-zone. The required neutral CT of ratio 1600/1 Class – PS installed at TRF A neutral bushing was connected & again complete scheme testing was carried out. With this correction the electrical protection system stability was found as per requirements. The TRF-A was again charged successfully.

Complete testing of in-zone/out-zone protection scheme with 3-phase primary injection kit should be ascertained during any change/replacement work. The Transformer-A was replaced during 2015-2016 & testing was done with single phase injection kit which was insufficient. So, a comprehensive standard testing procedure is being prepared for such replacement for thorough testing of the new installation at various sites.
