# Identification and Elimination of High Vibration Caused by Misalignment Induced Oil Whirl without Stoppage of the Machine

A case study

National Fertilizers Limited, Naya Nangal, Distt. Roop Nagar, Punjab

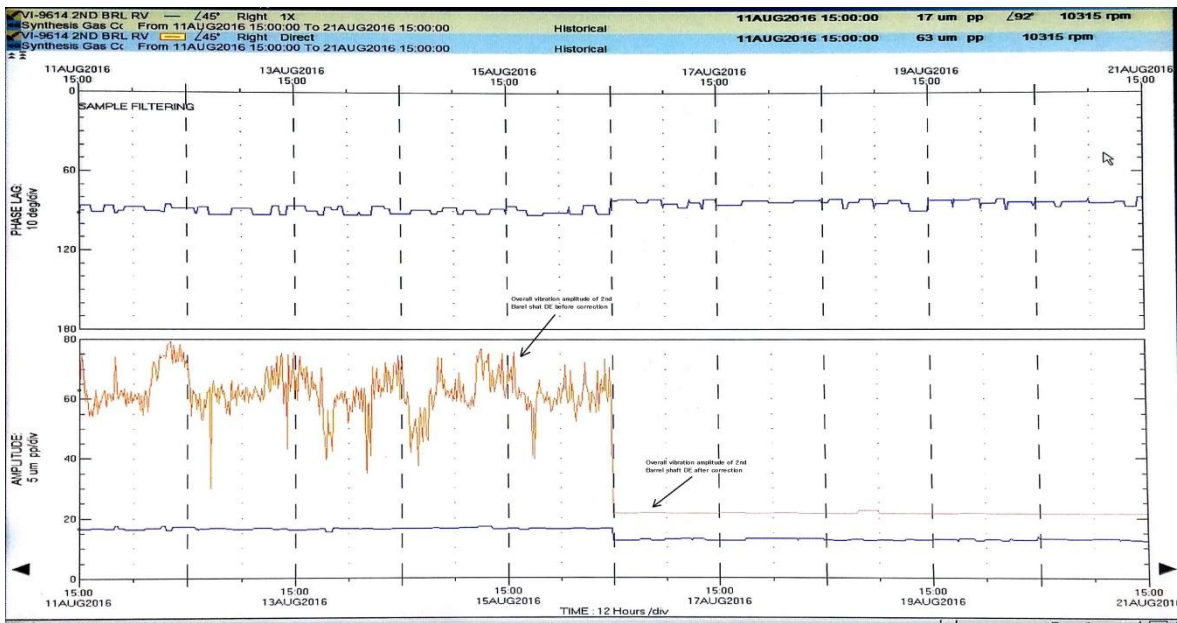
about 12 deg C, the vibration level on DE side of the rotor came down from 72-78 microns to 22-24 microns (**Figure 2**). This vibration level was well within normal acceptable vibration limits. The machine was kept under continuous close observation for full 24 hrs with adequate amount of steam outflow to maintain temperature of pedestals at approximately 75-80 deg C. Now there was no noticeable change in vibration amplitude of the machine even with increase in load on the machine. The waterfall plot (**Figure 7**) shows that subsynchronous vibration component at 0.42-0.43X has been eliminated altogether after heating DE side pedestals to the desired temperature. Thereafter it was decided to run the machine at pedestal temperature of 75-80 deg C with help of closely monitored heating steam. With round the clock close watch on the pedestal temperature & availability of heating steam by the shift-duty operating staff, The machine was successfully kept running at the desired load till annual shutdown of the plant in March-2017. On opening of the machine in March-2017 shutdown, alignment reading between 1<sup>st</sup> and 2<sup>nd</sup> barrel verified our investigation of misalignment causing lifting of the 2<sup>nd</sup> barrel rotor on DE side. In idle condition the 2<sup>nd</sup> barrel rotor was found 0.38 mm (dial indicator reading 0.76mm) down w.r.t. 1<sup>st</sup> barrel rotor against protocol of value of 0.26 mm (dial indicator reading 0.52 mm) and the DE side bearing clearance was found 0.18mm against design value of 0.13-0.17mm. Though gear couplings are capable to take care of this kind of misalignment, however in case light weight rotors when bearing clearances are on the higher side, even small misalignment in the train of rotors can cause fluid instability at an intermediate bearing having higher clearance. As a long term solution to the problem, during ATA-2017, radial bearing clearances were adjusted to the design values and the idle condition alignment was corrected to the protocol values.

Figure 2: Vibration trend of 2<sup>nd</sup> barrel after startup on 05.08.16

With complete back up of data and calculations, on 16.08.2016, both (left and right) drive end pedestals of the 2<sup>nd</sup> barrel were slowly and equally heated from the existing average temperature of 65 deg C to 80 deg C with a carefully regulated supply of a small quantity of steam in both the pedestal boxes. During heating process the lift of both left and right the pedestals was accurately measured with a dial gauge (**Figure 6**) and continuous temperature measurement was ensured with thermo-gun. As the pedestal lift approached 0.08 mm, average temperature increase of both left and right pedestals by

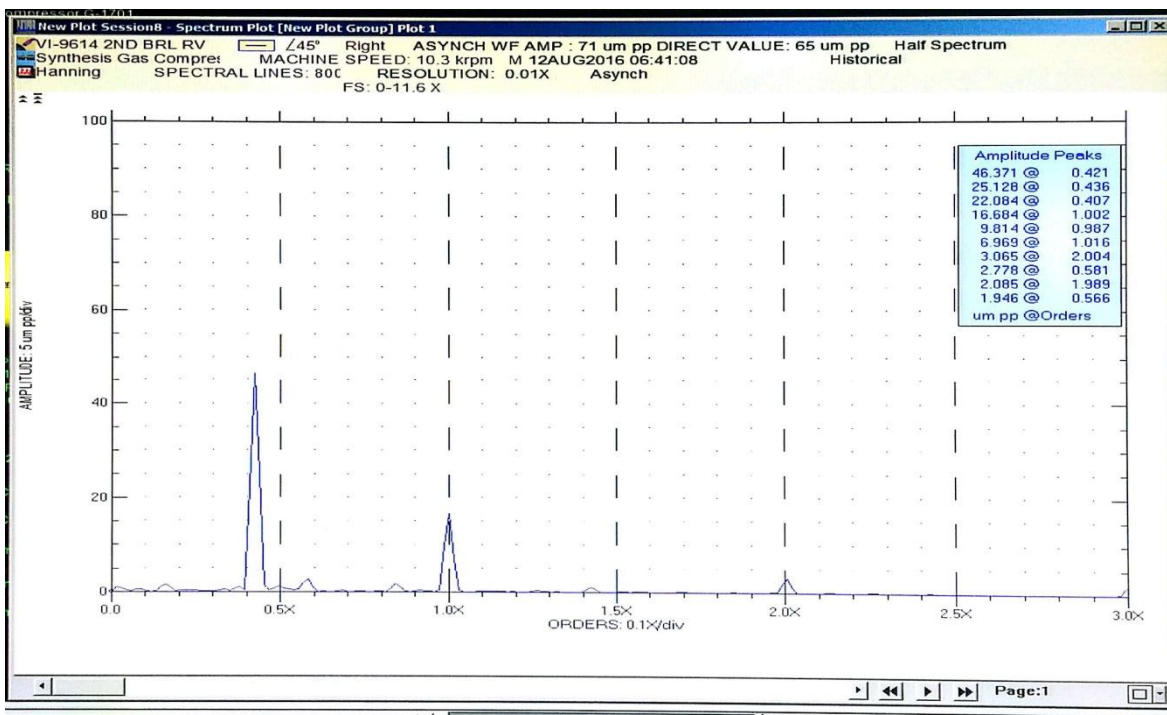
5. The predominant vibration peak in the DE side vibration spectrum (**Figure 3**) was at a Subsynchronous frequency of 0.42~0.43 multiple of the rotor speed (highest peak at 0.42-0.43 X in the spectrum).

The sub-synchronous peak at a frequency of 0.42-0.43X in the vibration spectrum indicated that there is some fluid induced instability and most probably oil whirl in the hydrodynamic bearings or in floating oil seal rings of the compressor. In the oil whirl condition a thick oil film starts moving in a swirling motion around the journal of the rotor. As the journal is moving at the rotor speed and the bearing inner surface remain under steady state the oil between the journal and the bearing inner surface rotates at speed approximately 42 to 45 % of the rotor speed. The whirling motion of the oil causes shaft to vibrate at a frequency of 0.42~0.48 of the rotor speed which is known as the oil whirl. The normal practice to eliminate the oil whirl or to reduce the effect of oil whirl on vibration amplitude is to change oil pressure or temperature in the forced feed hydrodynamic bearings. Due to hot climate conditions temperature of the oil in the lube oil header was running at 49 deg C which was already at higher end of the recommended normal oil temperature range of 40 to 50 deg C. So to avoid any other problem by increasing the oil temperature beyond recommended values, it was decided to decrease oil temperature by about 7-8 deg C. Lube oil temperature of 42 deg C was achieved by circulating available cold raw water through lube oil cooler with an existing provision for operating the syn gas compressor lube oil cooler on raw water in place of cooling water. This exercise resulted decrease in vibration amplitude by about 8-10 microns but even then as the compressor load was increased marginally beyond 95%, shaft vibration of 2<sup>nd</sup> barrel DE side again approached the trip value. Variation in oil pressure was neither feasible nor appropriate during running because of possibility of oil pressure going excessively low causing bearing failure due to specific construction of oil regulators in radial bearing oil line. Apparently, at this stage only option was to take shutdown for about 3-days to inspect the bearings and floating oil seal rings of the compressor. However, as with this decision production loss of 3-days and huge energy loss was evident, it was decided to carry out a detailed diagnosis of the problem for identification of the root cause before any corrective action.

Figure 3: DE side shaft vibration spectrum showing high peak at 0.42~0.43X

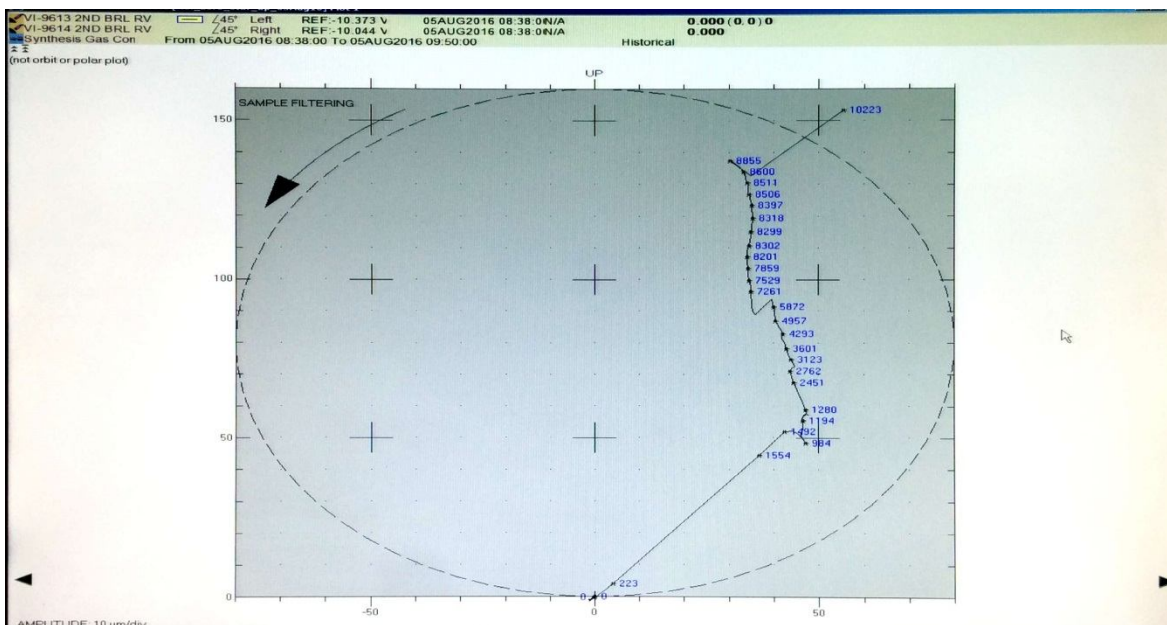
To investigate root cause of the problem, various steady state and transient vibration related plots of 2<sup>nd</sup> barrel were intensely analyzed. The average shaft centre line plot of DE bearing (**Figure 4**) plotted for transient condition during start up on 05.08.2016, indicated that DE side rotor shaft had lifted by approximately 155 microns (0.155 mm) from its bottom steady state condition which is almost equal to the bearing clearance of 0.16 mm. Ideally shaft lift during start up should be near to half of the bearing clearance and the average shaft centre line of the shaft should finally settle in 4<sup>th</sup> quadrant in the bearing clearance circle for anticlockwise rotation. Average shaft centre line plot of NDE bearing (**Figure 5**) indicated that the shaft was near to the centre of the bearing after

start-up. The shaft lift almost equal to the bearing clearance kept during assembly on DE side was clearly indicating that after start up on 05.08.2016 bearing clearance had increased to some extent and the rotor was no more supported on the normally desired thin oil film in the radial bearing. This is a condition of unloading of a radial bearing. Hence the excessive shaft lift from the bearing bottom i.e. unloaded radial bearing was permitting a thick oil film to move around the rotor journal in a swirling motion causing high vibrations in the rotor at oil whirl frequency of 0.42-0.43 of rotor speed. As there was no upward force for the rotor causing upward lift in the bearing clearance on DE side, it was concluded that misalignment alongwith slight increase in bearing clearance are the only predominant factors causing excessive lift of the rotor in one of the two bearings of the same shaft. Hence, detailed diagnosis of the problem had established that oil whirl related high vibration in 2<sup>nd</sup> barrel rotor on DE side is caused by unloading of the radial bearing due to misalignment.

Figure 4: 2<sup>nd</sup> Barrel rotor DE bearing shaft centre line plot during start up on 05.08.2016

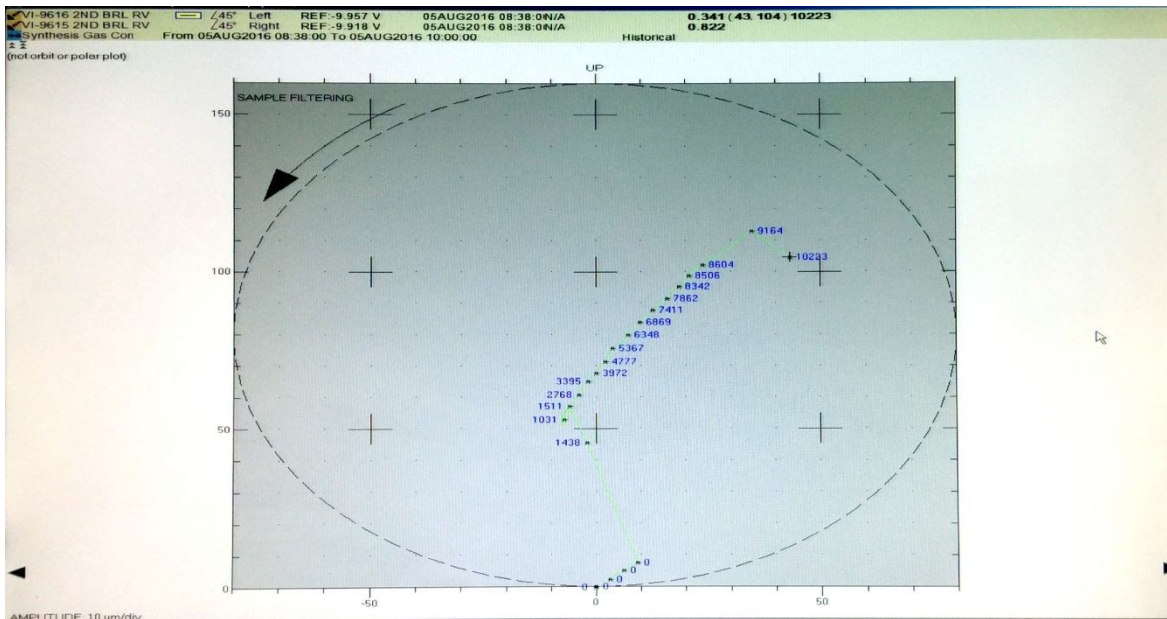
Figure 5: 2<sup>nd</sup> Barrel rotor NDE bearing shaft centre line plot during start up on 05.08.16

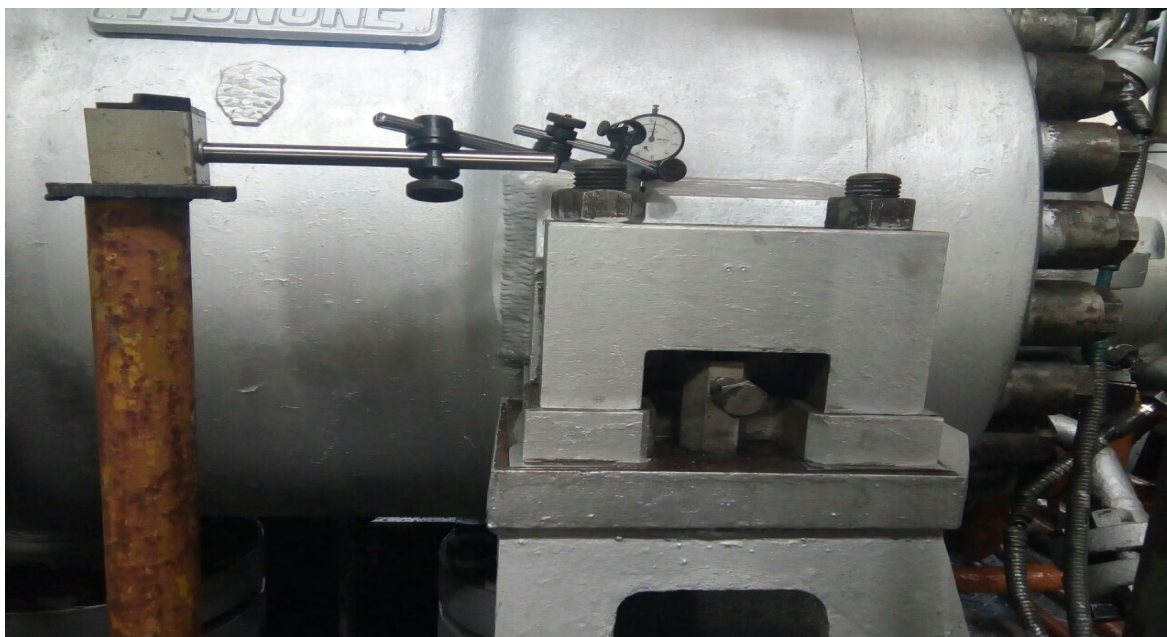
Figure 6: Measurement of 2<sup>nd</sup> Barrel DE pedestal lift during heating process

After exhausting all the conventional means to overcome the problem, a detailed brain storming session coupled with an intensive thought process, clinched an idea to raise the compressor barrel front pedestal without stopping the machine. Based upon height of the pedestal and coefficient of expansion of the pedestal material, it was calculated that if temperature of the DE side supporting pedestals is increased by 15 deg C, then the drive side bearing shell will be lifted by approximately 0.10 mm

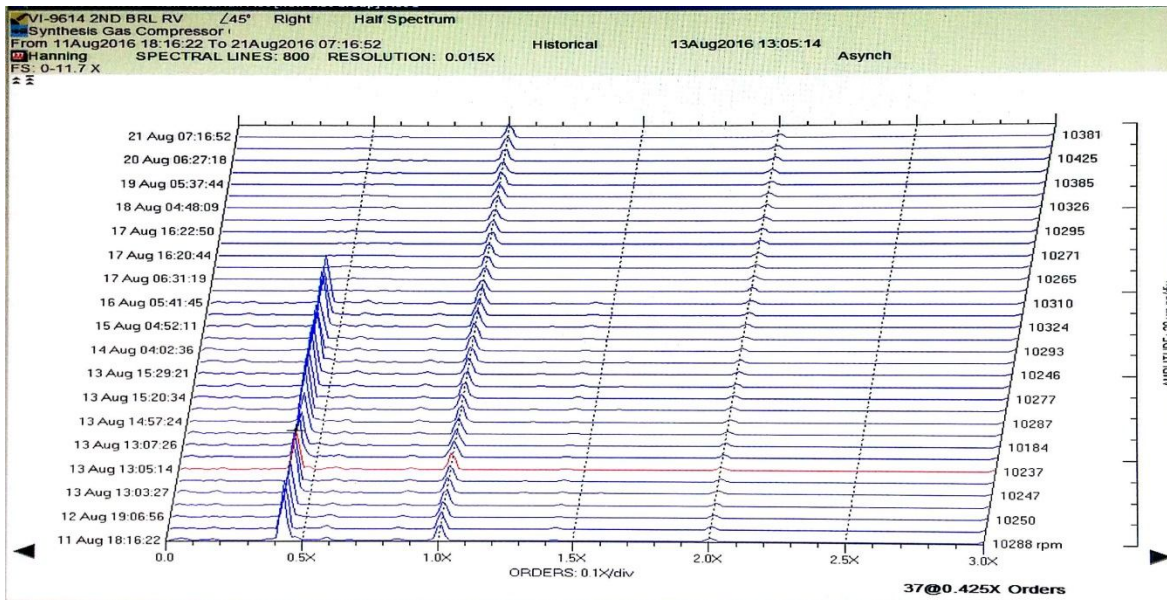
Figure 7: Waterfall plot showing elimination of 0.42~0.43X component after correction
