Tech Bytes

National Fertilizers Limited, Technical Periodical, (Q-2:2021-22)
(For internal circulation)

Problem of High Vibration during startup of GTG-2

S-200 Basket replacement and fresh synthesis catalyst loading & Activation

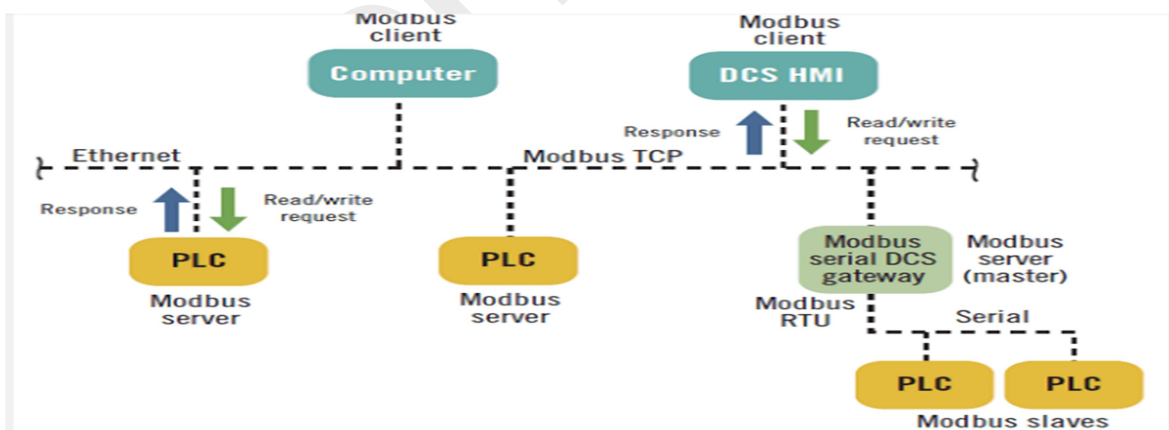
Modbus TCP architecture

Figure 2: Modbus TCP is typically implemented on an Ethernet network, and data transactions from a client are directed toward a server via an IP address.

Modbus is a communication protocol for transmitting information between electronic devices over serial lines (original version) or via the Ethernet, and is commonly used in process and factory automation. Modbus serial protocol (the original version) is a master/slave protocol, e.g. one master that controls the Modbus data transactions with multiple slaves that respond to the master's requests to read from or write data to the slaves. Modbus TCP, also known as Modbus TCP/IP, uses client/server architecture. These network architectures are shown Figures 1 and 2.

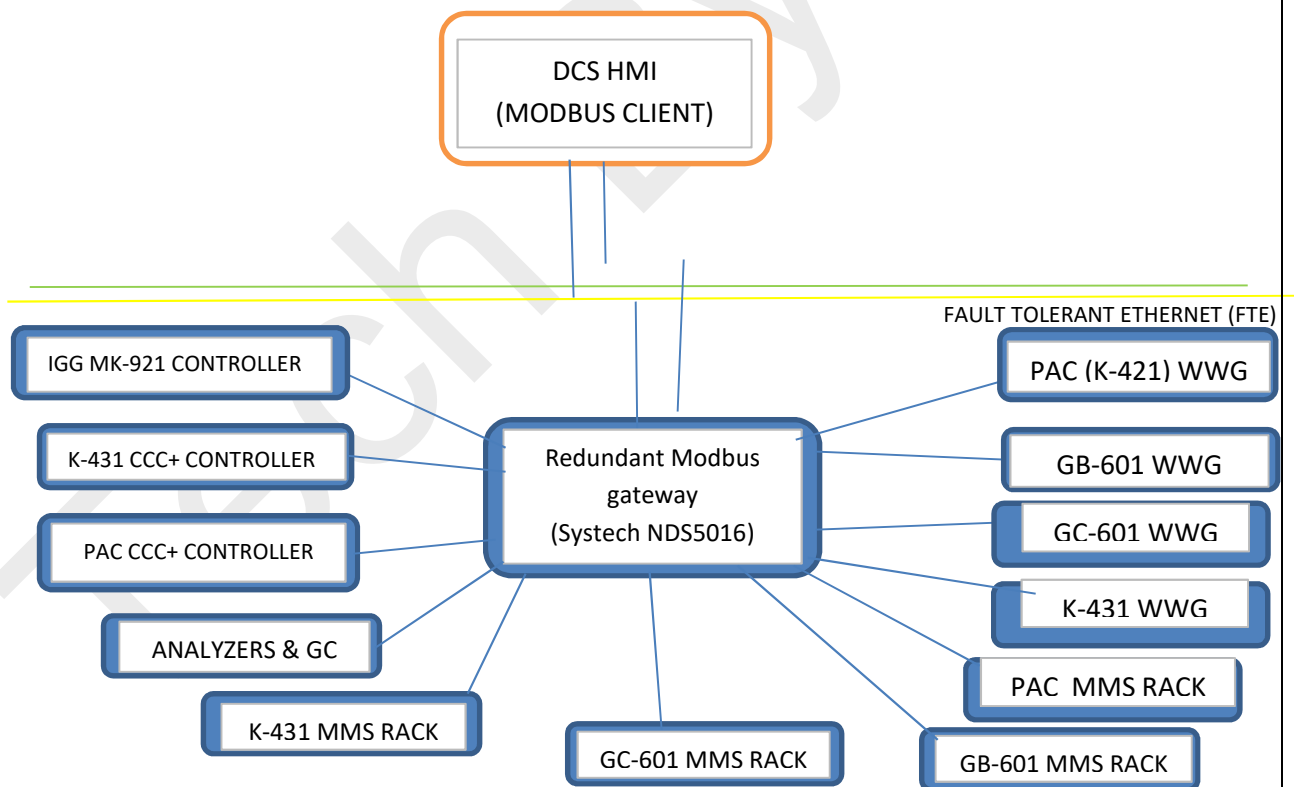
These devices are connected to DCS FTE (Fault Tolerant Ethernet) network using Systech make NDS5016RM Modbus serial gateway. This gateway device has 16 Nos. RJ45 serial ports for connecting third party devices.

Modbus system architecture for our system is as below:

On checking it was observed that Systech make Master Gateway starts interrupting the data (data get hang) in case any of slave device (any of 12 Nos. third party devices) is not responding within 1000 millsec (Timeout Period) due to any reason.

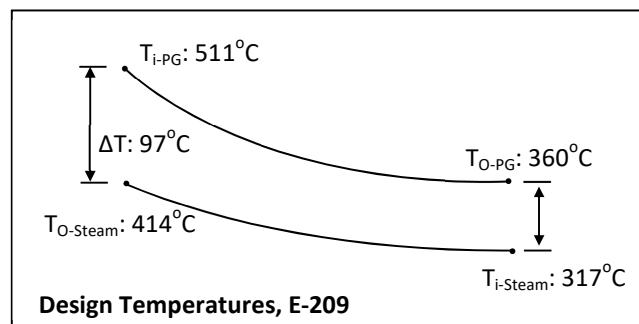
Steam super heater, E-209 has been installed in the Ammonia Feedstock changeover project, commissioned in 2013 in both Bathinda and Panipat unit of NFL. Since inception, deviation was observed in the inlet/outlet temperatures of process gas and steam w.r.t. design values which are shown below:

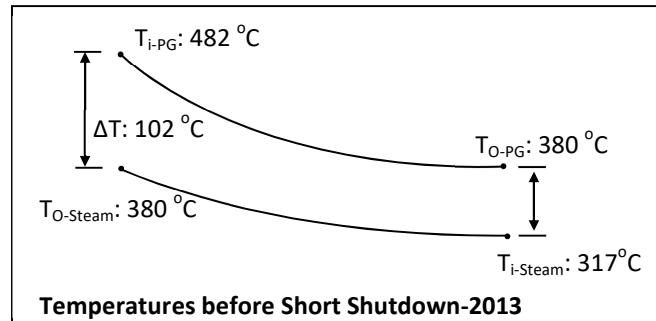
ΔT between PG-inlet and steam outlet is 97 deg C and the corresponding ΔT for Process Gas Outlet and steam inlet is 43 deg C. However actual values were found to be 102 deg C for Process Gas inlet and 63 deg C for PG-outlet.

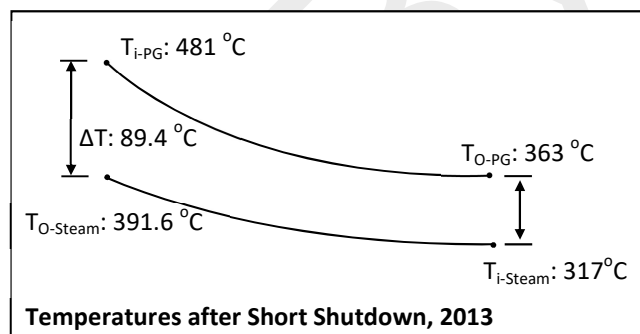
After carrying out the root cause analysis of the situation on the basis of available data, it was concluded that probable cause would be the bypassing of high temperature process gas through the bypass damper. To tackle this situation, an additional restriction plate made of SS-310 with 20 holes of diameter 18 mm, was installed during short shutdown in 2013 by M/s L&T in the path of bypass process gas to restrict its free flow. After installation of this perforated plate the operating temperatures were recorded as below:

Above data shows that the ΔT at gas outlet was reduced to 46 °C from earlier 63 °C causing significant rise in the degree of superheat of steam and hence resulted in higher waste heat recovery.

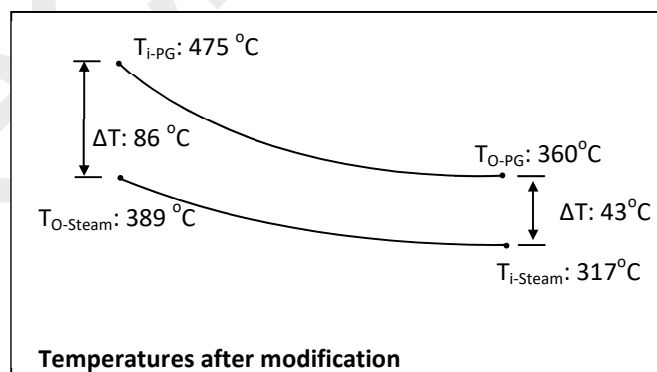
After carrying out the above modification, operating temperatures were found as below:

The above recorded data confirms the efficient operation of the steam super heater in accordance with the design parameters.
